## Main Street (between Pleasant Street & Lowell Road)

### Boston Road

## Main Street & Lowell Road Intersection

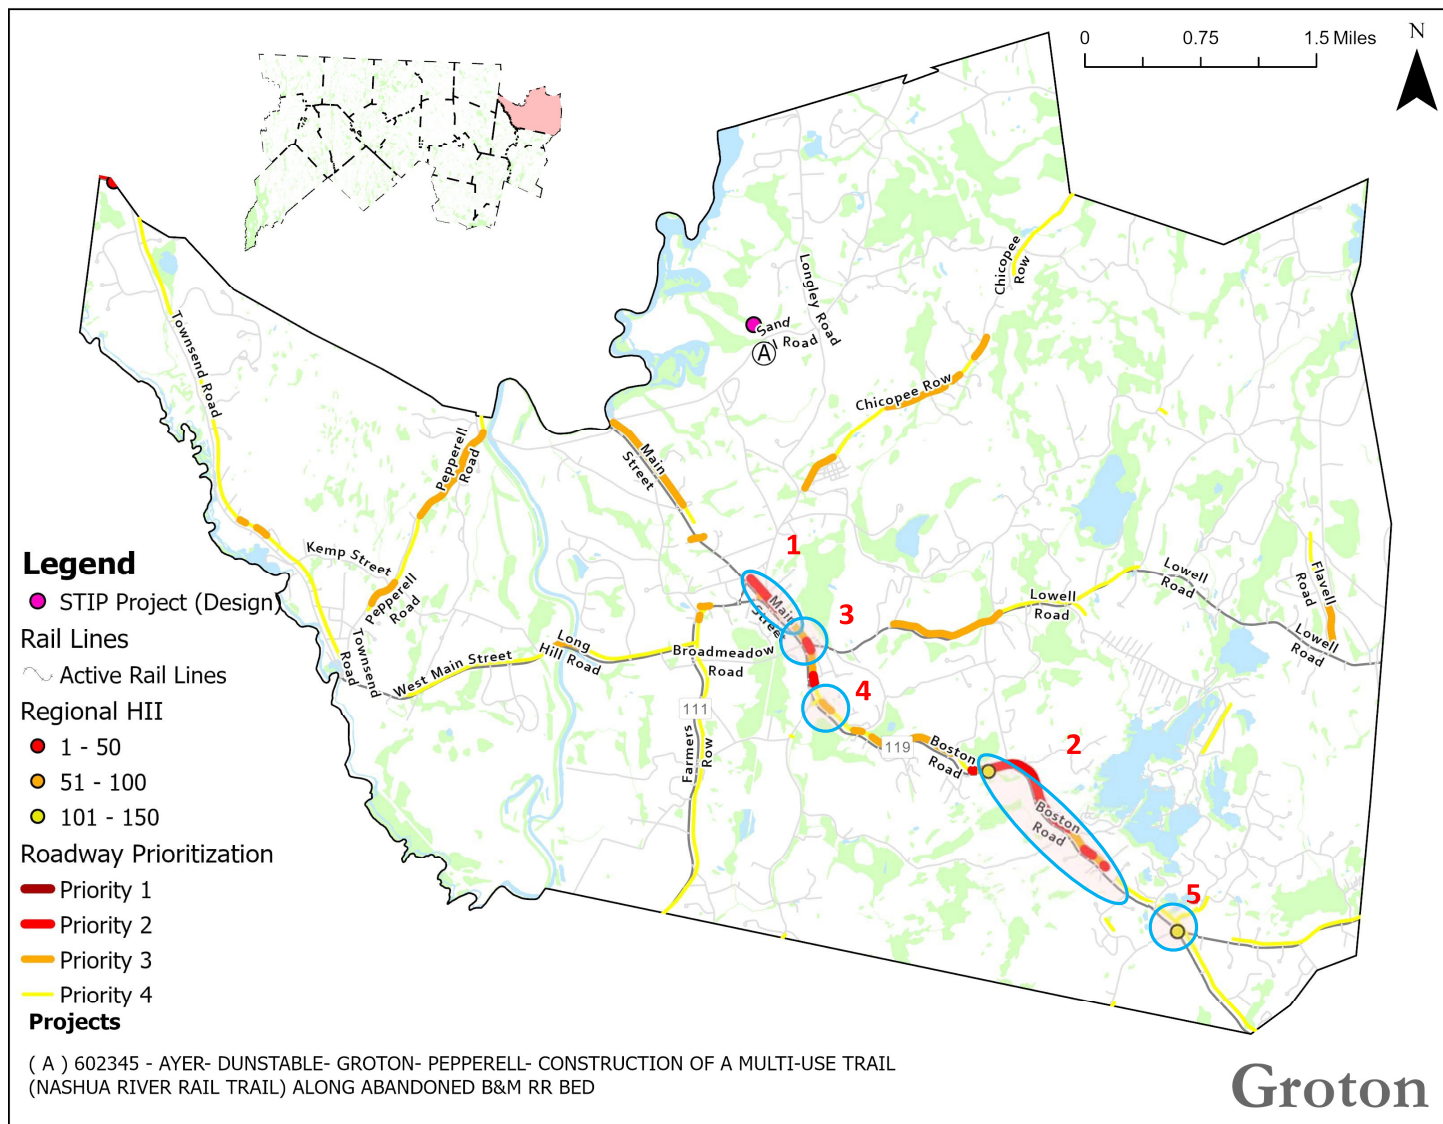
1.

- 48 total crashes.
- 23 rear-end, 13 angle, 10 sideswipe, and 6 other crashes.
- A pattern of rear-end crashes at bus stop-controlled intersections.
- Contributing factors include drivers failure to yield, inattention, and speeding.

- **Speed Feedback Signs:** Install speed feedback signs at key locations to encourage speed reduction.
- **Enhanced Delineation:** Paint pavement markings that delineate lane edges. Repaint stop bars on stop-controlled approaches.

- **Access Management:** Reduce driveway density where possible at businesses..

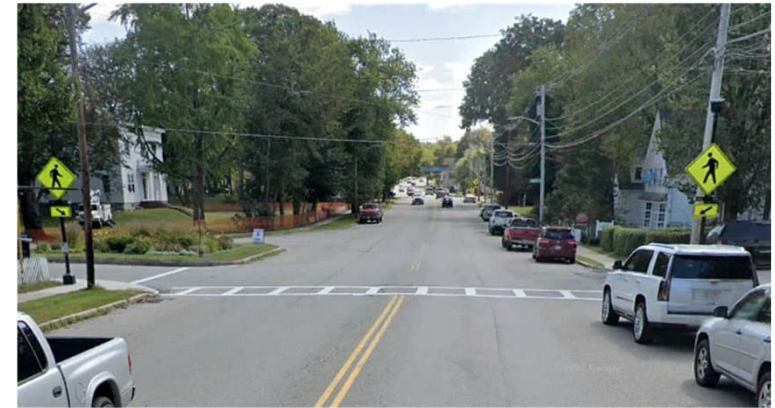
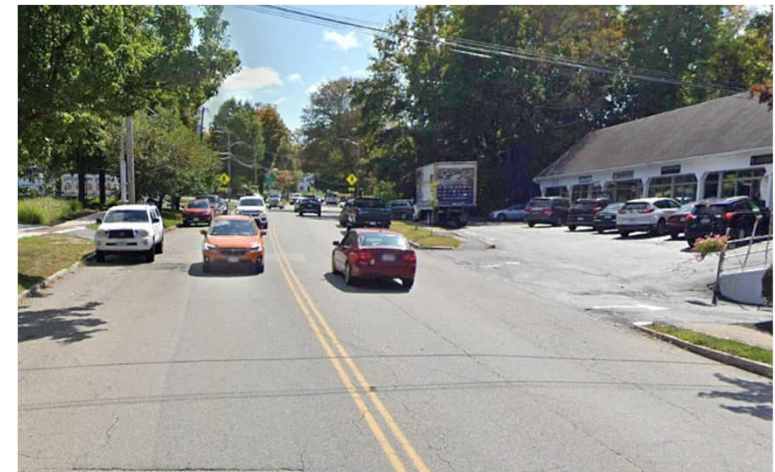
## 2.

- 47 total crashes
- 18 rear-end, 3 angle, and 4 other crashes.
- 22 single vehicle crashes with deer/tree/pole.
- A pattern of crashes in dark/roadway not lighted conditions around roadway curved sections.
- A pattern of rear-end crashes by the gas station.
- Contributing factors include drivers speeding, failure to yield, and following too closely.

- **Speed Feedback Signs:** Install speed feedback signs at key locations to encourage speed reduction ahead of intersections and busy driveways.
- **Install Lighting:** Install lighting poles where a crash pattern was identified.

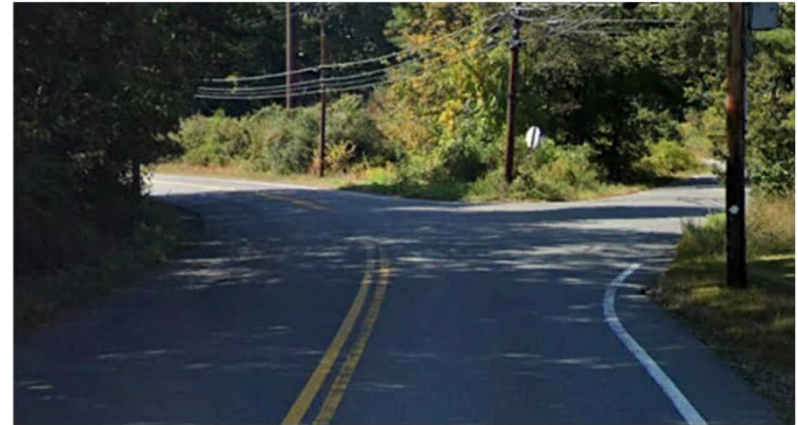
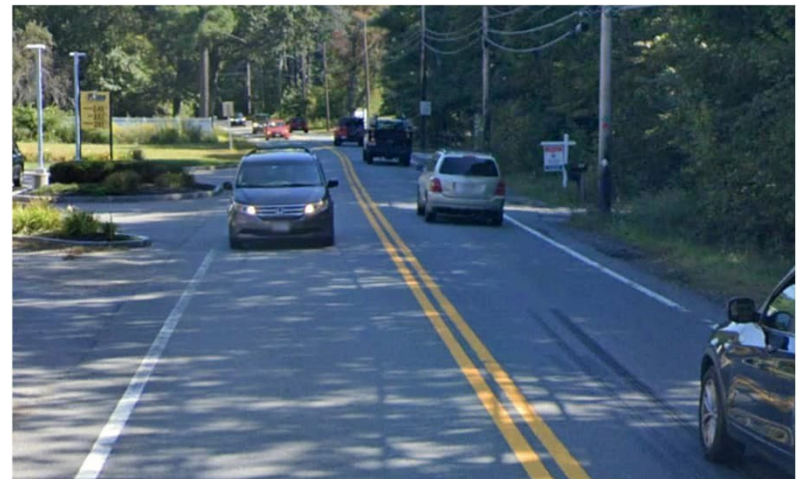
### 3.

- 32 total crashes.
- 14 angle, 9 rear-end, and 9 other crashes.
- 1 crash with pedestrian in dark conditions.
- A pattern of angle crashes.
- Contributing factors include drivers failure to yield and inattention/distraction.

- **Systemic Application of Low-cost Countermeasures:** Install doubled-up, oversized advance intersection warning signs on the through approach to increase driver awareness and recognition of the intersection and potential conflicts.
- **Speed Feedback Signs:** Install speed feedback signs in advance of the intersection to encourage slowing down.

- **No-parking Signs:** Prohibit on-street parking near intersections and crosswalks.

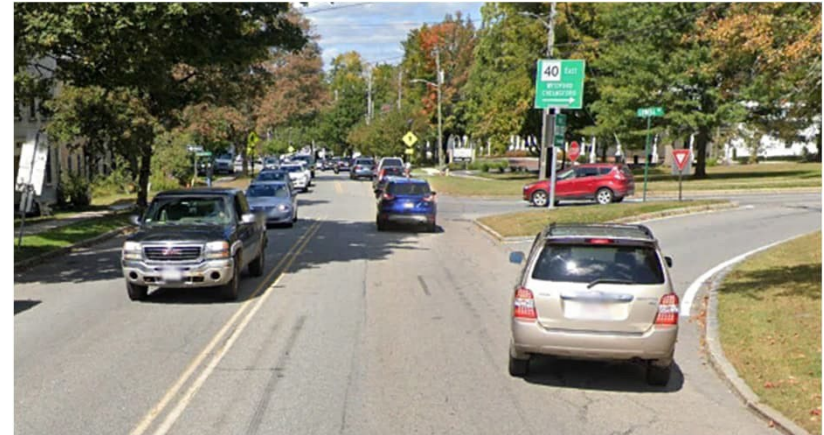
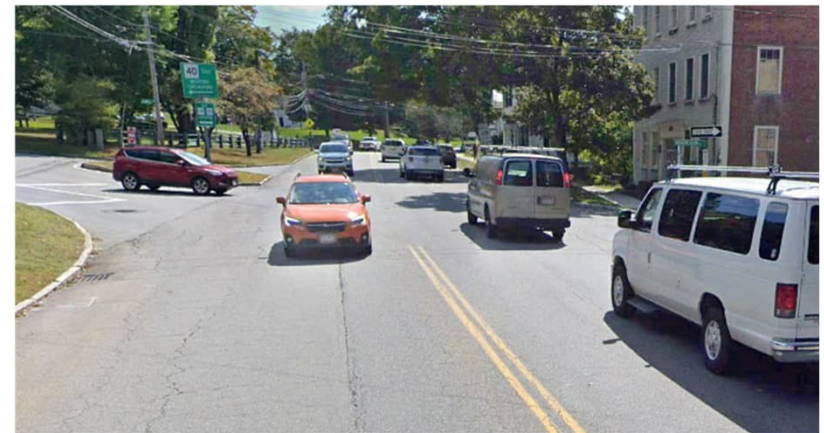
## 4.

- 13 total crashes.
- 6 single vehicle crashes with curb/tree.
- 4 rear-end, 2 sideswipe, and 1 angle crashes.
- Contributing factors include drivers running offroad and speeding .

- **Speed Feedback Signs:** Install speed feedback signs in advance of the intersection to encourage slowing down.
- **Enhanced Signage:** Install/maintain proper signage on minor approaches.
